AVStar Fuel Systems, Inc.
1365 Park Lane South
Jupiter, FL 33458

SERVICE BULLETIN

DOCUMENT: AFS-SB8

CARBURETOR THROTTLE BODY TO BOWL RETAINING SCREW INSPECTION

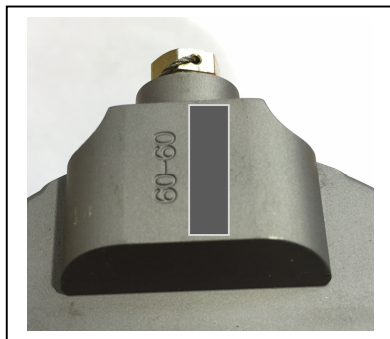
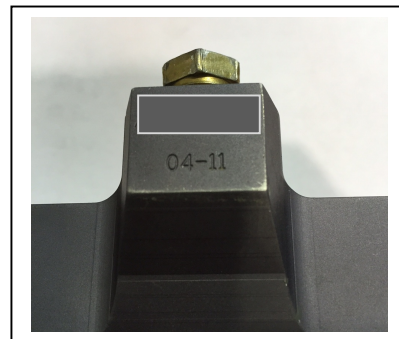
This Service Bulletin applies to all LVC-3-3A, LVC-3-3PA, LVC-5-4PA, LVC-5-5BPA, LVC-5-5PA, and all legacy aircraft carburetors manufactured by AVStar Fuel Systems, Inc. pre-dating August 2012 notated by date code on bottom of carburetor bowl near drain plug. See examples of date code below (part number covered for clarity). Service Bulletin in effect until overhaul or serviced per bulletin.
