SERVICE INFORMATION LETTER

LFC-10AD2 SERVOS INSTALLED ON LYCOMING IO-390 ENGINES

DOCUMENT: AFS-SIL-01

This Service Information Letter applies only to the following AVStar manufactured servo: Model LFC-10AD2 (Part Number AV2581500) installed on aircraft being operated primarily at high density altitude airports.

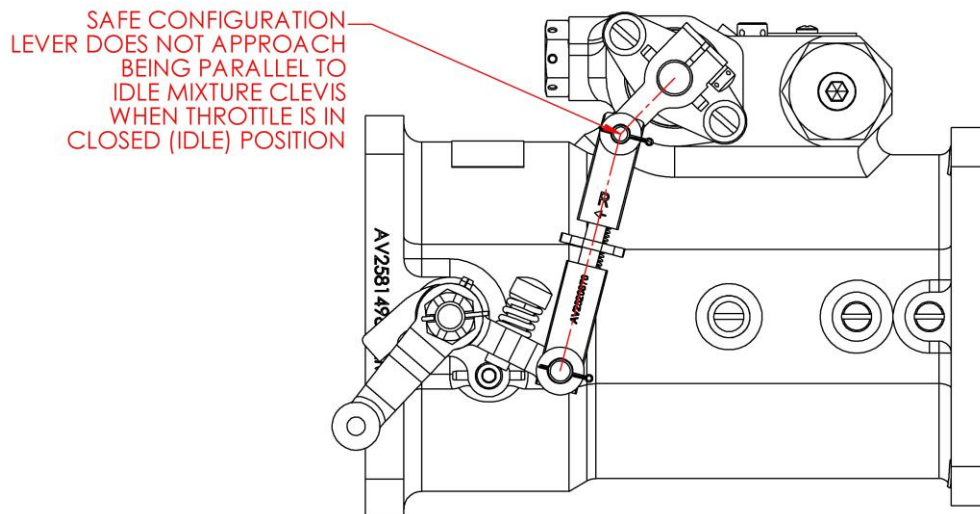
Fig 1 – Illustrates a Safe Operating Condition

- 4.1 Complete the required idle mixture clevis inspection (Appendix A) anytime the idle is adjusted whether made by the speed adjustment screw or mixture adjustment wheel. Complete this inspection prior to putting the engine or aircraft back into service.

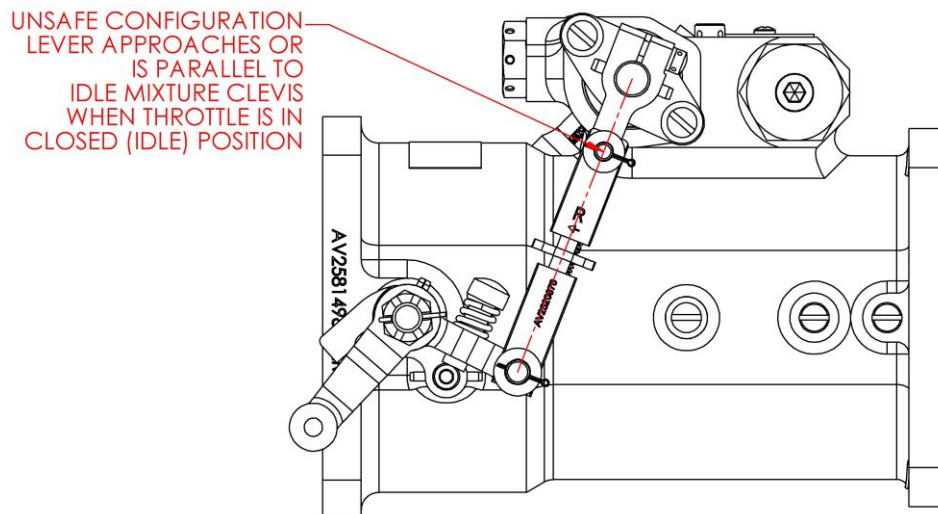
Fig 2 – Illustrates an Unsafe Operating Condition.

In this configuration or approaching this configuration can cause the clevis assembly to bind, especially during swift throttle movements. All precautions must be made to avoid this condition, as this can also lead to the condition illustrated in Figure 3.

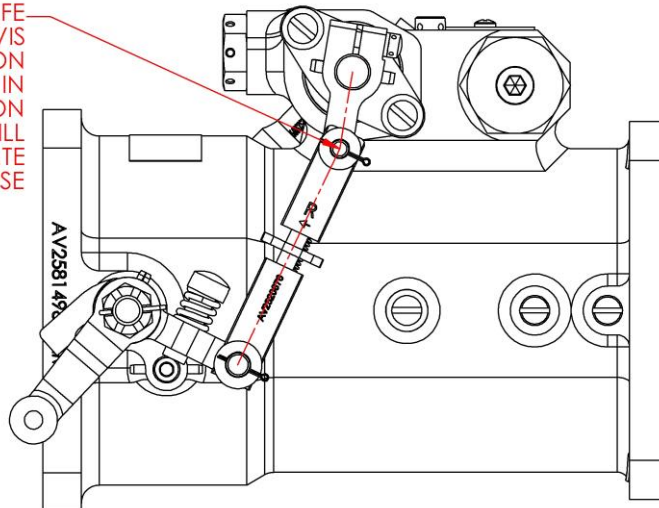
EXTREMELY UNSAFE
LEVER & IDLE MIXTURE CLEVIS
HAVE CHANGED ORIENTATION
WHEN THROTTLE IS IN
CLOSED (IDLE) POSITION
OPENING THROTTLE WILL
CAUSE LEVER TO ROTATE
COUNTER-CLOCKWISE

Fig 3 – Illustrates a Dangerous Condition which will result in the engine not being able to achieve power
