MANDATORY SERVICE BULLETIN

THE FRACTURE OF A FUEL DIAPHRAGM STUD IN FUEL SERVOS

DOCUMENT: AFS-SB6

REVISION: 2

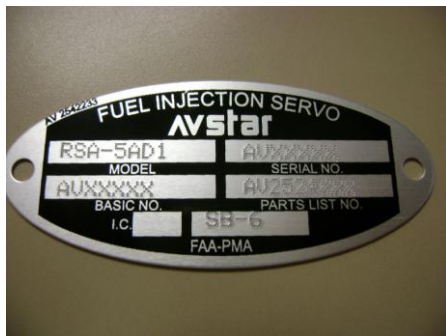
Fig 3

After replacement of the affected fuel diaphragm assembly, compliance with this service bulletin will be noted on the servo data tag by adding the mark SB6 as shown in Figs 3 and 4 below.
